TAT-12 & Sea2shore Cable Crossing Preliminary Mat Layout

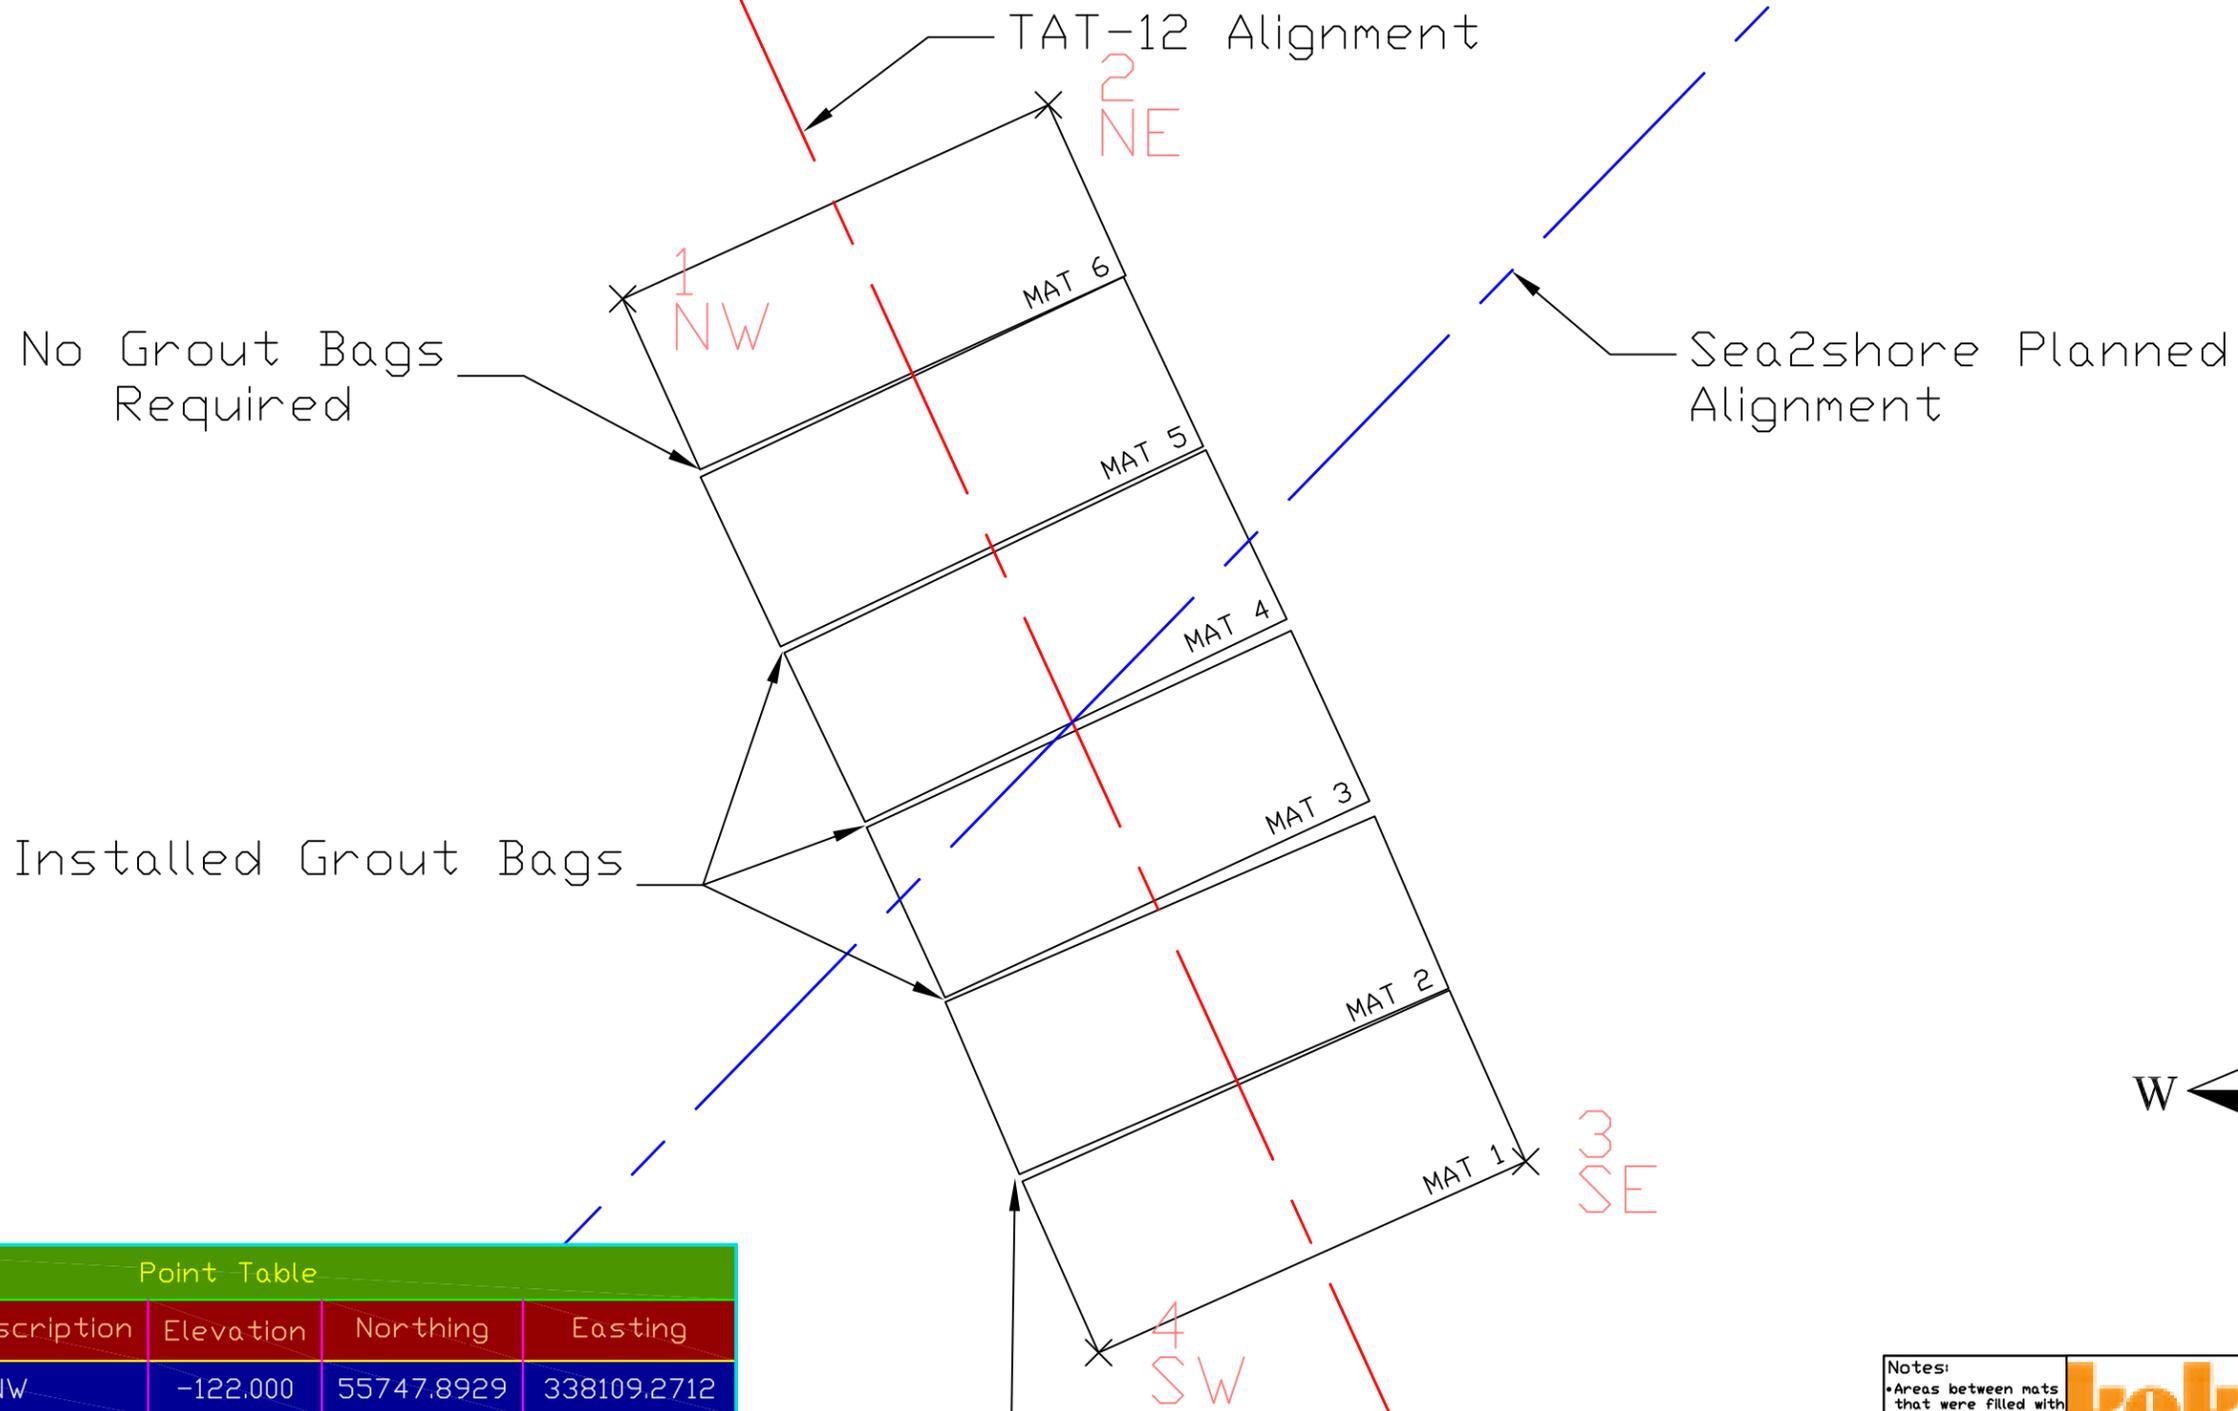
No Grout Bags Required

Installed Grout Bags

- Areas between mats that were filled with grout bags are noted
- Mats are arbitrarily labeled 1 thru 6
- A total of 22 grout bags were used between mats 2 and 3, 3 and 4, 4 and 5
- Survey points were determined using USBL survey beacons; accurate to +/-0.5 meter
